# Memorial Park

Gazetteer of Park Features

Burnley Borough Council - **Parks for People** Stage 1 Bid

# Gazetteer of Park Features

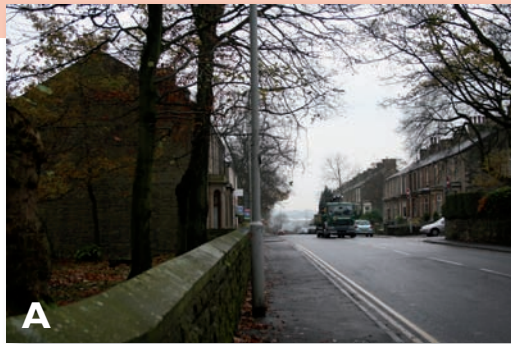
Ref	Characteristic or Feature	Good or Poor	Conservation Value	Potential Value
A	Boundary wall along Blackburn Road	Good	<b>High</b> – original feature wall constructed of local stone, in a local vernacular, to be retained at all costs	<b>High</b> - Creates a strong and emotive character to the northern boundary face of the Park as well as providing an excellent edge definition
B	Boundary wall piers	Good	<b>High</b> – original features to be retained	<b>High</b> - Frame the entrance and provides solid bases to (possible) entrance gates but consideration should be given to creating a grander entrance to the Park from Blackburn Road especially if car parking is to be considered to serve Knight Hill House
C	Bituminous macadam driveway entrance to Knight Hill House	Poor	<b>Low</b> – modern, overly practical response to access requirements to Knight Hill House	<b>Low</b> – this should be replaced and rethought in conjunction with car parking requirements at access to Knight Hill House and the wider Park

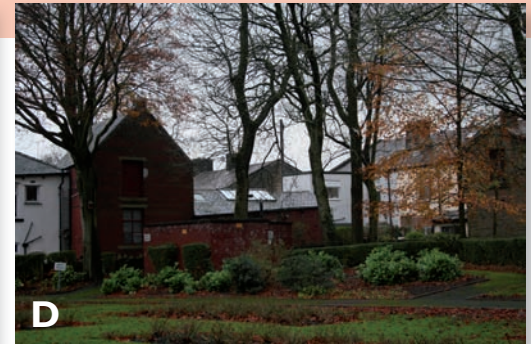
D	Planted area to north-west corner of Park	Poor	<b>Medium</b> – some mature trees worthy of conservation further to the findings of a tree survey	<b>Medium / Low</b> – some specimens worth keeping but the bulk could be removed to open the Park up to views from Blackburn Road

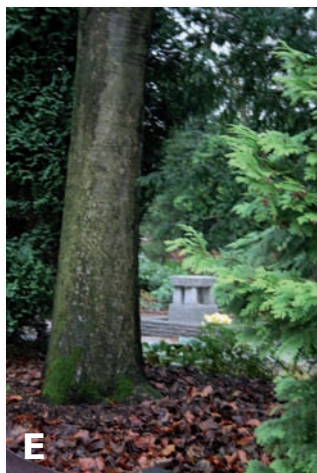
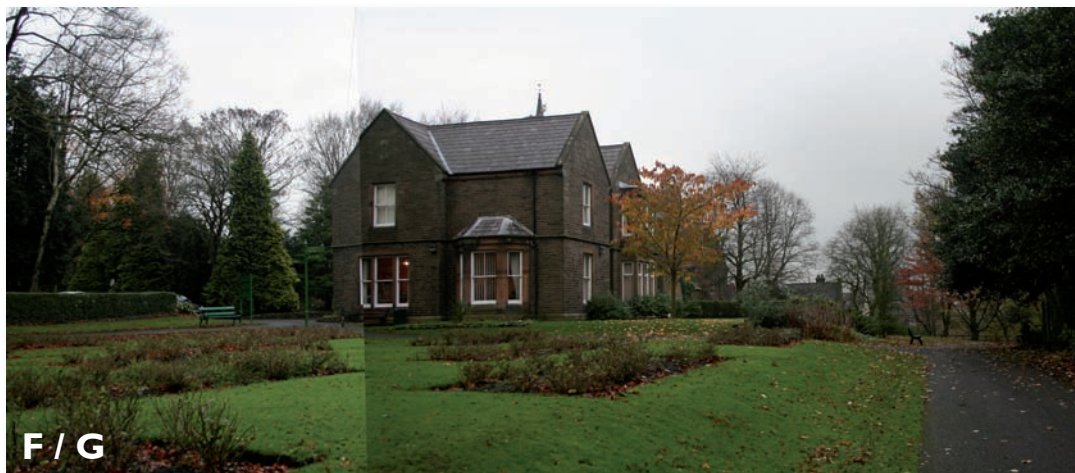
Ref	Characteristic or Feature	Good or Poor	Conservation Value	Potential Value
E	Air Crash Memorial	Good	<b>High</b> – a feature of high local importance and relevance	<b>High</b> – a rigorous maintenance plan will be required as well as potential for new planting. Consideration could be given to relocation as a feature in the Park separate from the War Memorial in whose shadow it is located less well served by access or views.
F	Knight Hill House	Good	<b>High</b> – a structure of little architectural merit but of good local vernacular and integrity	<b>High</b> – although possible redevelopment ideas have been discussed in the past the House offers many opportunities. Possible remodelling could occur to give the House a better sense of entrance and consideration should be given to constructing areas of hardstanding (i.e. terrace, patio) linking to the house to allow for greater diversity of use.

G	Formal Rose Beds in lawn area	Good	<b>Medium</b> – a classic landscape feature from the period of the Park's creation the Rose Beds are a well liked feature in the Park	<b>Medium / High</b> - well maintained and worthy of retention but open to opportunities of relocation and establishing new relationships with Knight Hill House <b>Medium / High</b> - well maintained and worthy of retention but open to opportunities of relocation and establishing new relationships with Knight Hill House

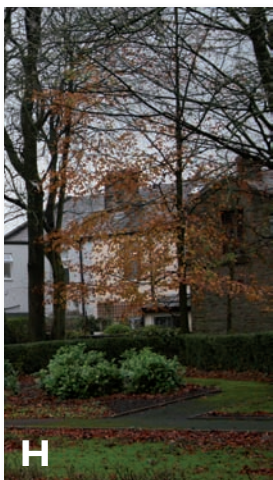
Ref	Characteristic or Feature	Good or Poor	Conservation Value	Potential Value
H	Mature Tree Stock	Good	<b>High</b> – some specimens appear to have survived from the Park's creation	<b>High</b> – selectively retain and thin out specimens to provide better setting for Knight Hill House and memorial
I	Herbaceous borders to south face of Knight Hill House	Poor	<b>Medium</b> – conceptually well worth retaining but physically in need of a rethink and better maintenance	<b>Medium / High</b> – a potentially highly attractive feature, especially in conjunction with the stone walls throughout the Park. Possible expansion of planting areas should be considered in proximity to Knight Hill House if new terracing created
J	Air Raid Shelter	Good	<b>High</b> – a feature of historical interest, although limited in size and features well worth conserving	<b>High</b> – with appropriate management possible avenues of use on event days are readily conceivable

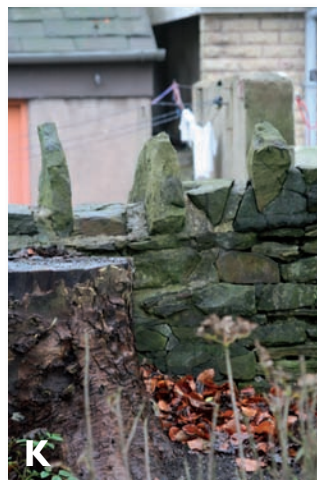
K	Boundary walls with stone copes	Good	<b>High</b> - original walls constructed of local stone, in a local vernacular, to be retained at all costs	<b>High</b> - Create a strong and emotive character to the boundaries of the Park and provide an excellent edge and setting for features.
L	Kiosk and walled lawn area	Good	<b>High</b> – Kiosk of medium aesthetic merit set amongst attractive stone walls and lawn areas provides an excellent practical feature for the Park	<b>High</b> – Currently used as a cafe on event days and throughout the summer the extant power supply provides a diversity of possible use

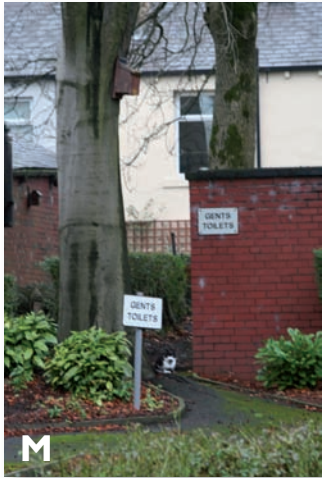
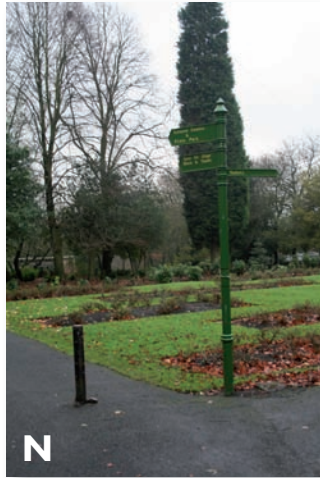
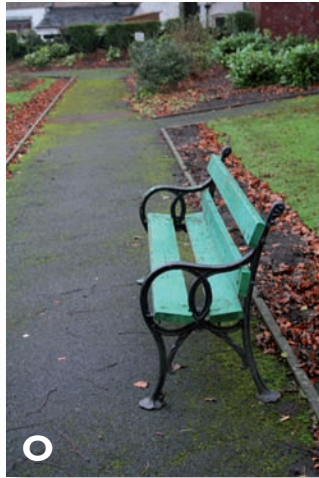
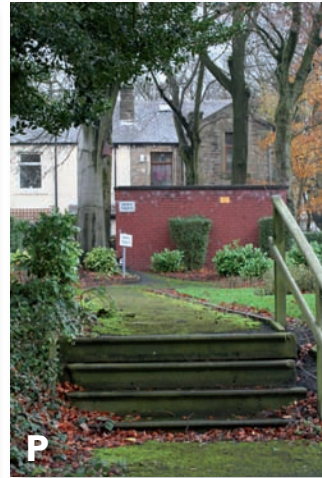
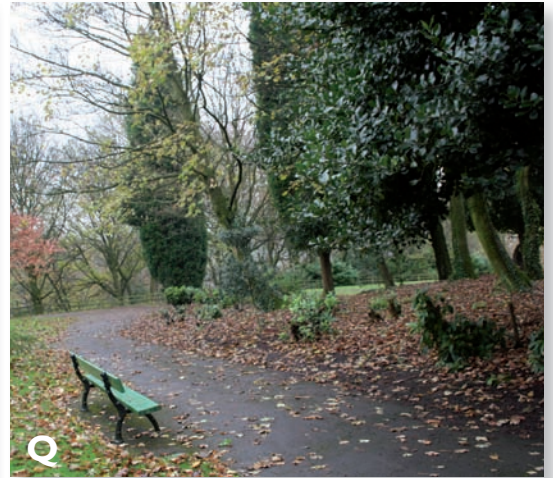
Ref	Characteristic or Feature	Good or Poor	Conservation Value	Potential Value
M	Toilet facilities	Poor	<b>Medium</b> – a useful feature that would require refurbishment if retained	<b>High</b> – a useful feature for event days that could become more fitting in appearance for its location
N	Finger posts	Good	<b>Medium / High</b> – useful features of attractive and fitting appearance in need of cleaning and retouching but well worth retention	<b>High</b> – flexible, useful features that would represent a useful cost saving if retained as well as providing a street furniture theme style
O	Bench seats	Poor	<b>Low</b> – the seating for the entire Park needs to be rethought and a single approach and style taken rather than the chaotic appearance that the piecemeal specimens currently create in the Park	<b>Medium</b> – some of the seating frames are attractive and could be resealed with timber slats as long as new frames could be constructed to create a suite throughout the Park

P	Steps leading up to Rose beds	Poor	<b>Low</b> – stone steps with a timber handrail that could be lifted, retained and relaid but this location needs to be considered	<b>Medium</b> – features of possible re-use value that should be retained and used in the Park to retain a heritage aesthetic
Q	Bitumous macadam footpaths, varied width	Poor	<b>Medium</b> – the paths provide attractive and well-used circuitous routes although in poor condition and unlikely to meet modern access requirements	<b>High</b> – resurfacing work needs to be undertaken with possible consideration of use of differing materials to establish route hierarchies and staging posts for views, street furniture and disambulant users

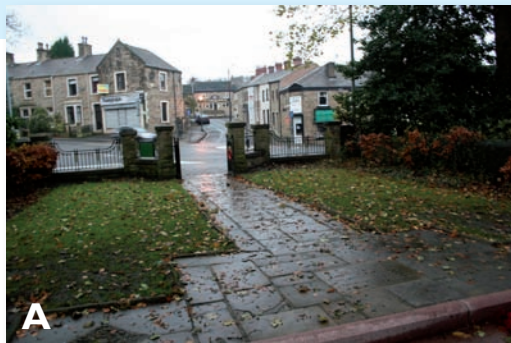
**A**

Ref	Characteristic or Feature	Good or Poor	Conservation Value	Potential Value
<b>A</b>	Boundary wall and railings along Blackburn Road	Good	<b>High</b> – original feature wall constructed of local stone, in a local vernacular; to be retained at all costs	<b>High</b> - Creates a strong and emotive character to the northern boundary face of the Park as well as providing an excellent edge definition along this main entrance point
<b>B</b>	Wall piers on Blackburn Road	Good	<b>High</b> – original features to be retained	<b>High</b> - Frame the entrance and provides solid bases to (possible) entrance gates
<b>C</b>	Cast iron pedestrian access gates to Blackburn Road	Good	<b>High</b> – original features to be retained	<b>High</b> – retain and establish regular maintenance regime to maintain appearance to a 'face' feature of the Park
<b>D</b>	Stone steps leading to Gates (Item C)	Good	<b>High</b> – original features to be retained	<b>High</b> – retain and establish regular maintenance regime to maintain appearance to a 'face' feature of the Park

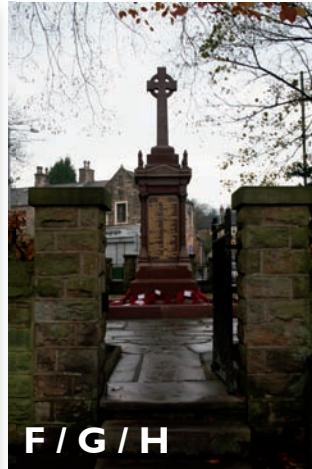
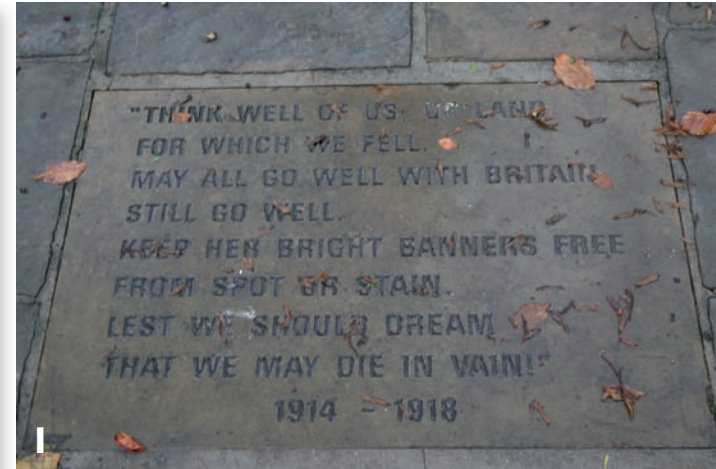
Ref	Characteristic or Feature	Good or Poor	Conservation Value	Potential Value
E	Stone wall to eastern site boundary with stone copes	Good	<b>High</b> - original walls constructed of local stone, in a local vernacular, to be retained at all costs	<b>High</b> - Creates a strong and emotive character to the boundaries of the Park as well as providing an excellent edge definition and setting for features. Some repairs required.
F	Stone wall and piers to Memorial southern boundary	Good	<b>High</b> - original walls constructed of local stone, in a local vernacular, to be retained at all costs	<b>High</b> - Creates a strong and emotive character to the boundaries of the Park as well as providing an excellent edge definition and setting for features.
G	Stone paving	Good	<b>High</b> – attractive flooring to Park's named feature	<b>High</b> – retain and replace with like for like when required
H	War Memorial	Good	<b>High</b> – attractive and highly prized feature of local importance	<b>High</b> – focal feature for the Park to be subject to high level of maintenance

I	Inscription stone	Good	<b>High</b> – attractive setting feature at the foot of the Memorial	<b>High</b> – retain and be subject to high level of maintenance

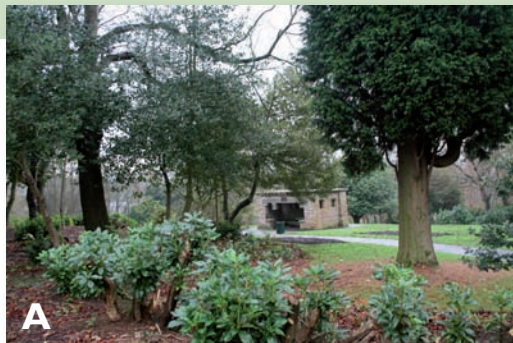
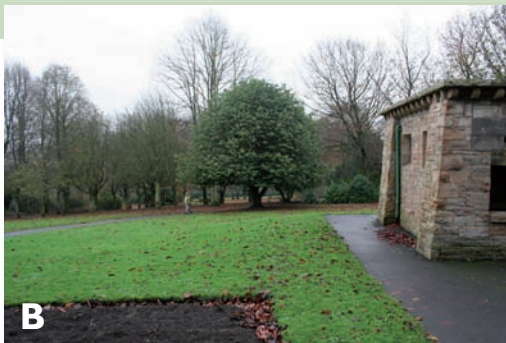
Ref	Characteristic or Feature	Good or Poor	Conservation Value	Potential Value
<b>A</b>	Mature tree planting to area surrounding, and above, air raid shelter	Good	<b>High</b> – many specimens appear to have survived from the Park's creation	<b>High</b> –retain and selectively thin out specimens (according to an Arboricultural Management Plan [AMP] for the Park) to open up views to the hills and countryside beyond Padiham to the south and provide views up to Knight Hill House from the Park. Care is to be taken to maintain visual screening of Shuttleworth Mead Estate.
<b>B</b>	Mature tree planting aligning path edges	Good	<b>High</b> – many specimens appear to have survived from the Park's creation	<b>High</b> –retain and selectively thin out specimens (according to the AMP) to open up views to the hills and countryside beyond Padiham to the south. Care is to be taken to maintain visual screening of Shuttleworth Mead Estate for views obtained from the lawns and shelters.

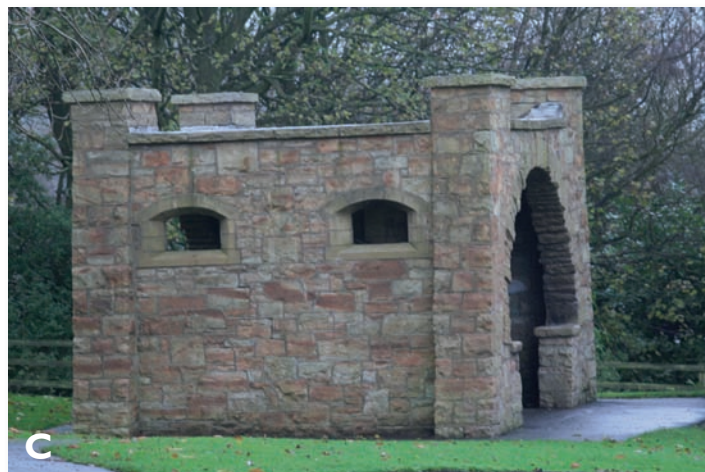
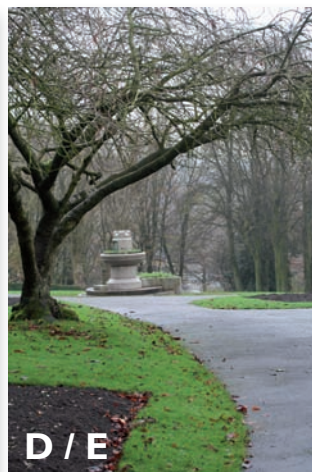
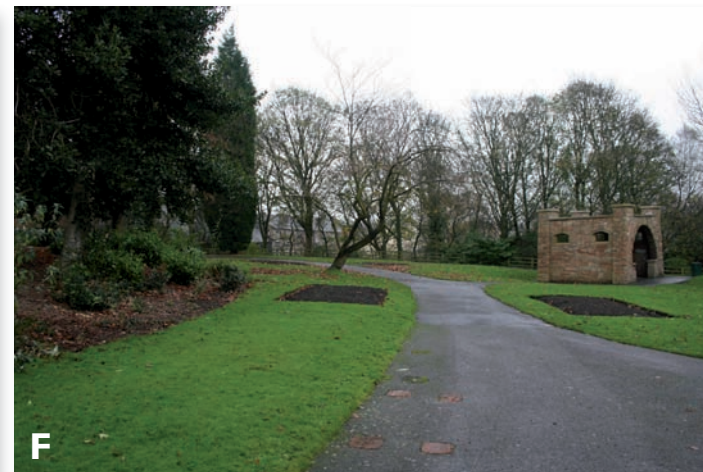
Ref	Characteristic or Feature	Good or Poor	Conservation Value	Potential Value
C	Stone shelters	Good	<b>High</b> – stone construction creates features of local vernacular that offer shelter and practical use year-long	<b>High</b> – ideal locations from which to base the selection of tree thinning regimes to create from views to the countryside
D	Bituminous macadam footpaths 2.75m wide	Poor	<b>Medium</b> – the paths provide attractive and well-used circuitous routes although in poor condition and unlikely to meet modern access requirements	<b>High</b> – resurfacing work needs to be undertaken with possible consideration of use of differing materials to establish route hierarchies and staging posts for views, street furniture and disambulant users
E	Stone Fountain	Good	<b>High</b> – possibly an original feature, a stone construction ornamental fountain retained from its original location in the southern section of the Park and moved to a location agreed with the Friends Group	<b>High</b> – a feature of local interest and import it acts as a focal point in the Park whose location could be considered but is currently considered to be good

F	Formal bedding planting beds	Poor	<b>Low</b> – scattered and chaotic bare earth areas that add seasonal colour but need a location and structure redesign	<b>High</b> – a holistic planting scheme for the Park should be undertaken which includes prized areas of annual plantings creating seasonal displays that retain elements of year-round interest

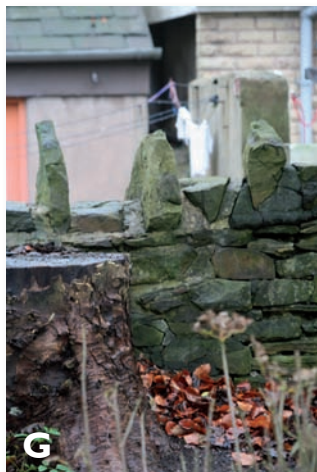
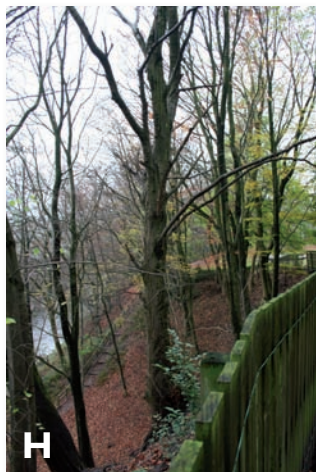
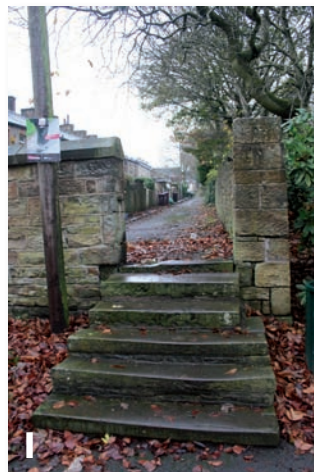
Ref	Characteristic or Feature	Good or Poor	Conservation Value	Potential Value
G	Boundary stone wall with stone copes	Good	<b>High</b> - original walls constructed of local stone, in a local vernacular, to be retained at all costs	<b>High</b> - Creates a strong and emotive character to the boundaries of the Park as well as providing an excellent edge definition and setting for features. Some repairs required.
H	Timber fencing aligning footpath to eastern edge	Good	<b>High</b> – of fairly recent construction and good integrity the fencing is unobtrusive and is a discrete element in the landscape	<b>Medium</b> – practical and efficient design response to safety issues that should be retained with thought possibly given to a new access from the Middle Slopes area down to the former Bandstand located on the Woodland Walk through the ruined Terraces
I	Stone steps to Bridge Street	Good	<b>High</b> – integral stone riser and treads match boundary walling and create a bijou feature although the doubling up of access on Bridge Street offers the opportunity of relocating steps to elsewhere in the Park	<b>High</b> – the material and character of the steps require they be retained at all costs either in their current location or put to use elsewhere in the Park within areas of heritage character

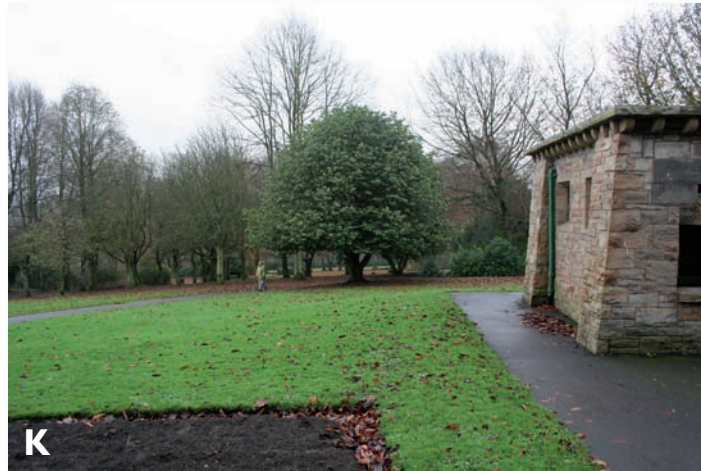
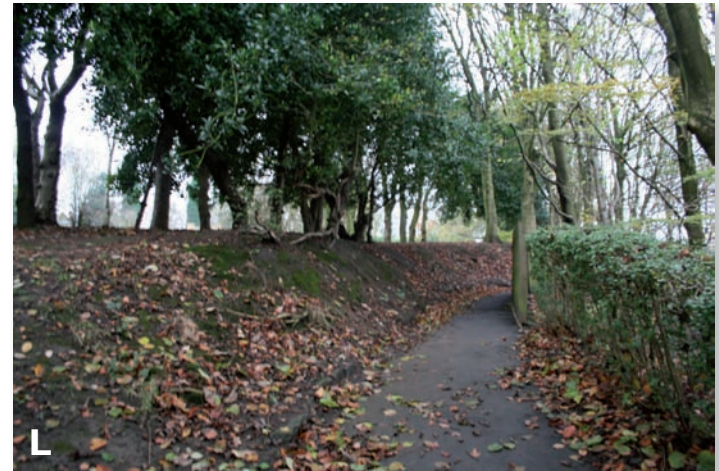
Ref	Characteristic or Feature	Good or Poor	Conservation Value	Potential Value
J	Shrub planting to western boundary wall	Poor	<b>Medium</b> – uninspiring areas of shrub planting that are maintained well and represent solid structural specimens but require a rethink in terms of concept, colour, form and relationship to the boundary walling and integrity	<b>High</b> – the quality of the existing specimens require their retention in situ as a solid existing structure but the beds need substantial additions with some existing specimens in need of division and thinning
K	Grass lawn areas	Good	<b>High</b> – well maintained and neat lawns that provide much needed amenity open space for Padiham residents	<b>High</b> – good open space character for passive, informal use year-round with consideration to be given to the obtaining of views to the countryside to the south of Padiham, planting schemes and AMP

L	Bare banks aligning footpaths to the western edge of the area	Poor	<b>Medium</b> – conservation to be considered in conjunction with Tree Survey for impact on root systems if grading out of the banks is proposed	<b>Low</b> – unimportant facet of the landscape of little positive impact that could be considered for grading out into the lawns

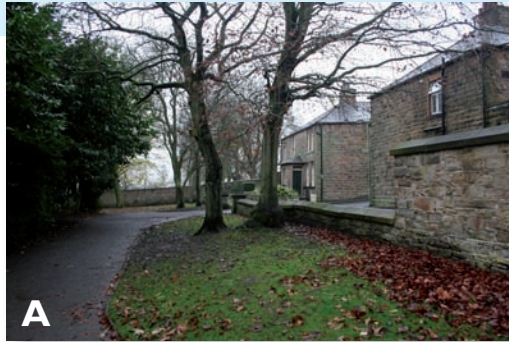
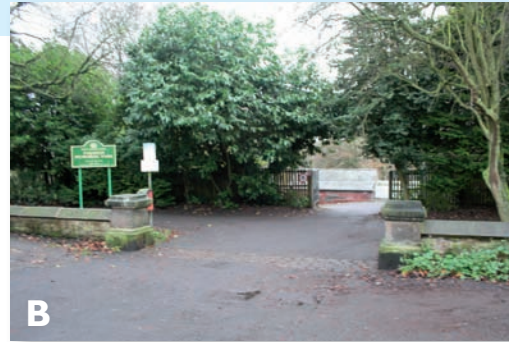
Ref	Characteristic or Feature	Good or Poor	Conservation Value	Potential Value
A	Stone wall to Bridge Street entrance	Good	<b>High</b> - original walls constructed of local stone, in a local vernacular; to be retained at all costs	<b>High</b> - Creates a strong and emotive character to the boundaries of the Park as well as providing an excellent edge definition and setting for features. Consideration should be given to maintaining vehicular access from Bridge Street and whether the height of the wall can be raised to tie into adjoining walls
B	Stone piers to Bridge Street entrance	Good	<b>High</b> – original features to be retained	<b>High</b> - Frame the entrance and provides solid bases to (possible) entrance gates. Should this vehicular access be stopped up then the piers should be lifted and used elsewhere in the Park befitting their lower height

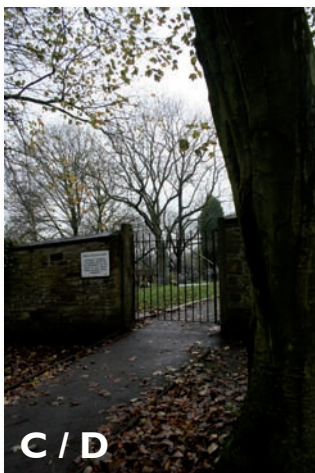
C / D

Ref	Characteristic or Feature	Good or Poor	Conservation Value	Potential Value
C	Stone wall dividing park from cemetery including stone copes	Good	<b>High</b> - original walls constructed of local stone, in a local vernacular, to be retained at all costs	<b>High</b> - Creates a strong and emotive character to the boundaries of the Park as well as providing an excellent edge definition and setting for features.
D	Gate between park and cemetery	Poor	<b>Low</b> – practical and suits purpose but should be subject to consideration of access from Park to the cemetery	<b>Low</b> – of a simple aesthetic creating low key access but there would be no requirement for retention if the access is redesigned or removed
E	Bitumous macadam footpaths 1.75m wide	Poor	<b>Medium</b> – the paths provide attractive and well-used circuitous routes although in poor condition and unlikely to meet modern access requirements	<b>High</b> – resurfacing work needs to be undertaken with possible consideration of use of differing materials to establish route hierarchies and staging posts for views, street furniture and disambulant users

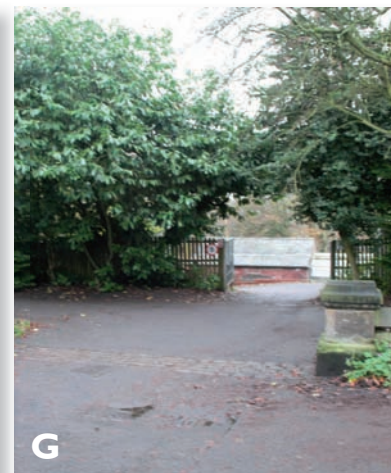
F	Maintenance depot buildings	Poor	<b>Low</b> – functional, single-storey buildings of no merit but currently in use by BBC Parks Dept. Greenhouses offered out for use to local community but no interest received	<b>Low</b> – depot clearance should be considered with relocation of maintenance operations to a site on Park Road. Resulting space would only be to the benefit of the Park and residents on Bridge Street.
G	Bitumous macadam access to maintenance depot	Poor	<b>Low</b> – modern, overly practical response to access requirements to maintenance depot and as an informal access to the cemetery	<b>Low</b> – to be considered in conjunction with depot removal and stopping up of vehicular access to the Park from Bridge Street

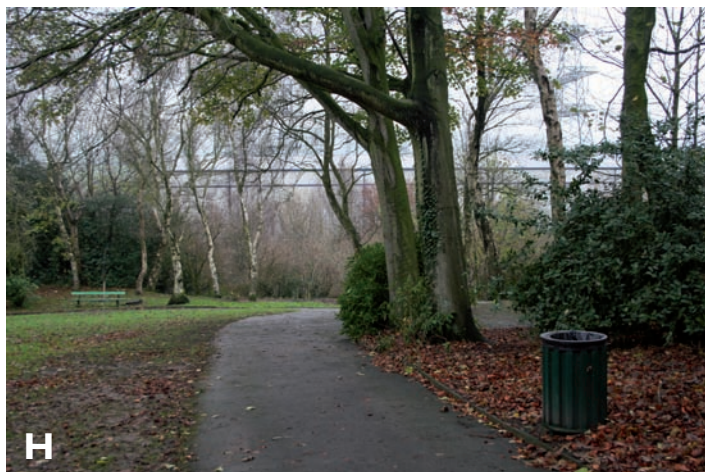
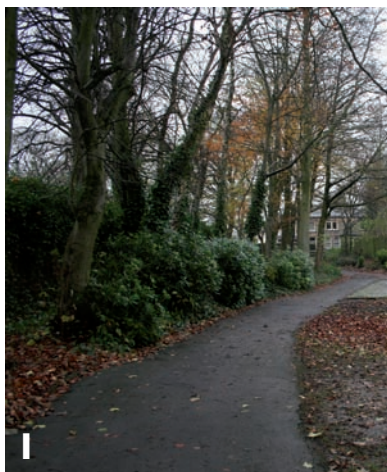
Ref	Characteristic or Feature	Good or Poor	Conservation Value	Potential Value
H	Mixed shrub planted bank to depot edge	Poor	<b>Medium</b> – uninspiring areas of shrub planting that represent solid structural specimens but require a rethink in terms of concept, colour, form and relationship to the space they define. Also maintenance appears to be an issue as large areas of scrub are appearing throughout	<b>High</b> – the quality of the existing specimens suggest their retention in situ (dependant on the possible redesign of the existing depot and its proposed new use) as a solid existing structure but the beds need substantial additions with some existing specimens in need of division and thinning
I	Mature Tree Stock	Good	<b>High</b> – some specimens appear to have survived from the Park's creation with some more recent additions of structural and aesthetic interest	<b>High</b> –retain and selectively thin out specimens (according to the AMP) to open up views to the hills and countryside beyond Padiham to the south. Care is to be taken to maintain visual screening of Shuttleworth Mead Estate

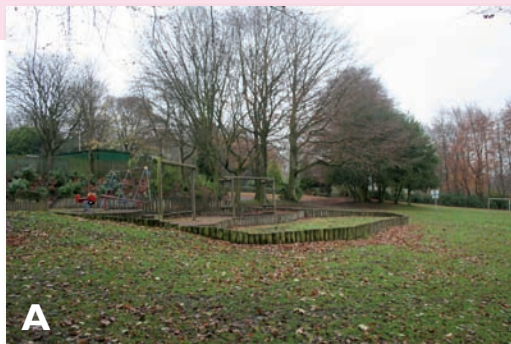
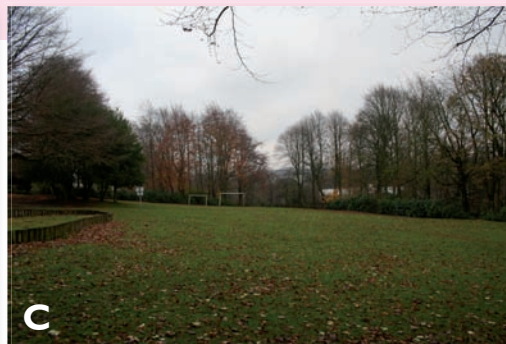
Ref	Characteristic or Feature	Good or Poor	Conservation Value	Potential Value
A	Children's Play Area	Poor	<b>Low</b> – a well used but uninspiring layout that requires a complete redesign to integrate better with the other Park areas and provide better play opportunity	<b>High</b> – well used by the local residents the potential exists for an exciting play space making better use of level changes, sheltered location and possible relocation for visual integration with other areas of the Park
B	Children's play equipment in Play Area	Poor	<b>Low</b> – practical and uninspiring a redesign of the Play Spaces would require new equipment	<b>Low</b> – the equipment requires replacement
C	Sports equipment (goal posts)	Poor	<b>Low</b> – current siting on a semi-steep sloping site, lack of maintenance and lack of evident use suggests removal or relocation	<b>Medium</b> – the sloping nature of the northern section of the Park suggests that sports pitches are unusable although the equipment could be repaired and reused elsewhere

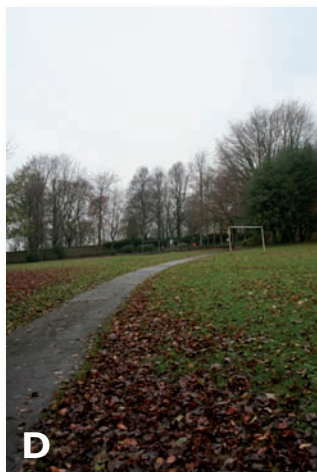
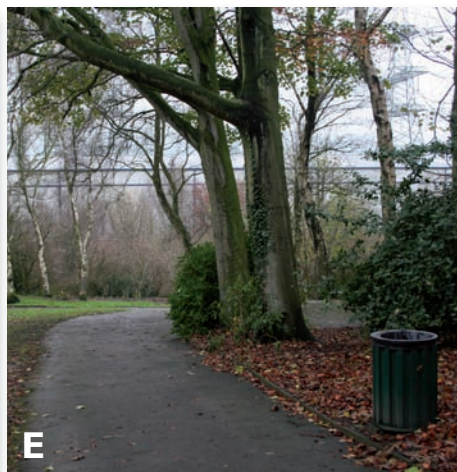
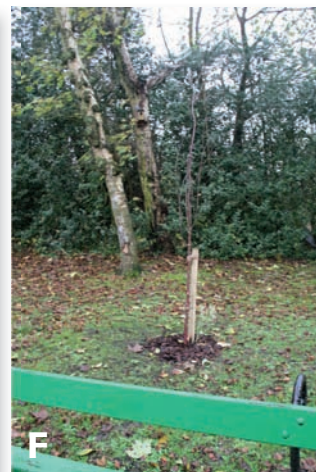
Ref	Characteristic or Feature	Good or Poor	Conservation Value	Potential Value
D	Bituminous macadam footpaths 1.75m wide	Poor	<b>Medium</b> – the paths provide attractive and well-used circuitous routes although in poor condition and unlikely to meet modern access requirements	<b>High</b> – resurfacing work needs to be undertaken with possible consideration of use of differing materials to establish route hierarchies and staging posts for views, street furniture and disambulant users
E	Bay for former Toilet block	Good	<b>High</b> – retain surface and research integrity of existing services and sewers that previously served this location	<b>High</b> – possible rebuilding of facility to be investigated to provide additional services in the Park
F	Community Orchard	Good	<b>High</b> – a recent community action the orchard specimens are young and of good evident growth	<b>High</b> – the concept and planting area could be expanded upon to create a unique character area and one of possible wildlife interest

G	Stone wall aligning southern boundary of the Park	Good	<b>High</b> - original walls constructed of local stone, in a local vernacular, to be retained	<b>High</b> – although largely obscured by boundary planting the walls create an emotive character to the Park boundary as well as providing an excellent edge definition and setting for features. Some repairs required.
H	Mature Tree Stock	Good	<b>High</b> –specimens appear to have survived from the Park's creation with additions considered to have been planted over the life span of the Park	<b>High</b> –retain and selectively thin out specimens (according to the AMP) to open up views to Padilham Linear Park. Care is to be taken to maintain visual screening of Shuttleworth Mead Estate.

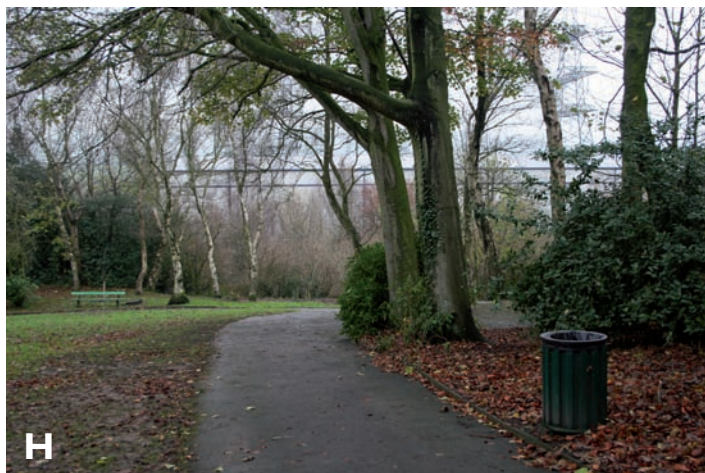
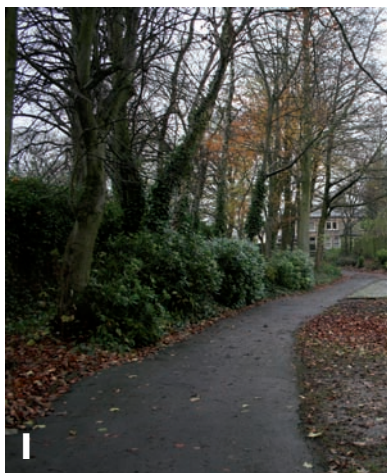
Ref	Characteristic or Feature	Good or Poor	Conservation Value	Potential Value
I	Grass lawns	Good	<b>High</b> – spaces of good amenity and active recreation use	<b>High</b> – well used spaces to be retained with possible consideration to subtle reprofiling for play and amenity purposes
J	Mixed shrub planting to southern Park boundary	Poor	<b>Medium</b> – uninspiring areas of shrub planting that are maintained well and represent solid structural specimens but require a rethink in terms of concept, colour, form and relationship to the boundary integrity	<b>High</b> – the quality of the existing specimens require their retention in situ as a solid existing structure but the beds need substantial additions with some existing specimens in need of division and thinning
K	Mixed coniferous planting adjoining Open Air Stage area	Good	<b>High</b> – attractive aesthetic providing year-round colour	<b>High</b> – possible expansion of concept and planting area into a pinetum creating seasonal interest throughout the Park

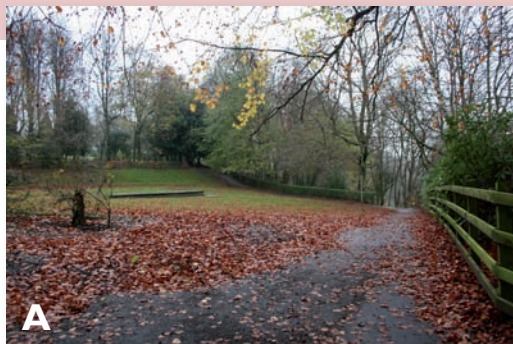
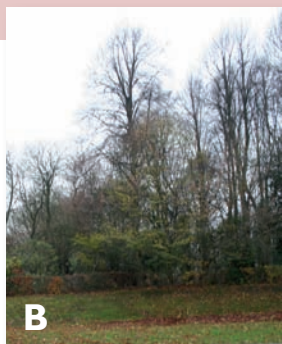
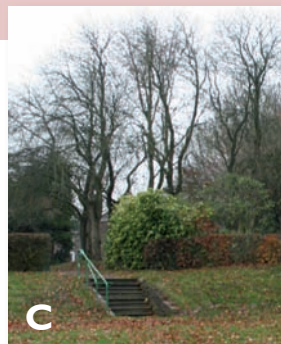
Ref	Characteristic or Feature	Good or Poor	Conservation Value	Potential Value
A	Octagonal stone bandstand foundation	Good / Poor	<b>High</b> – sourced from Gawthorpe Park the stone edgings are worthy of retention and cleaning but the centre requires removal	<b>High</b> – creates a heritage aesthetic although could be moved to another area more befitting of its smaller size and scale
B	Grass lawns and internal facing banks	Good	<b>High</b> – well maintained and strong sward ideal for amenity and performance space and informal gathering and seating	<b>High</b> – purpose-made amphitheatre that requires possible rethink for flexibility of use and consideration of all-weather, year-round conditions
C	Stone steps at western boundary with side walls	Good	<b>High</b> – integral stone tread and riser of heritage aesthetic to be retained in situ or for use elsewhere in the Park	<b>High</b> – consideration should be given to creating a grander entrance to the performance space on this axis using the steps with new handrails or for re-use of the steps in the Park, possibly on the Bandstand Terraces

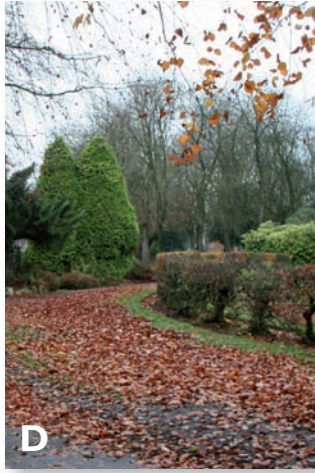
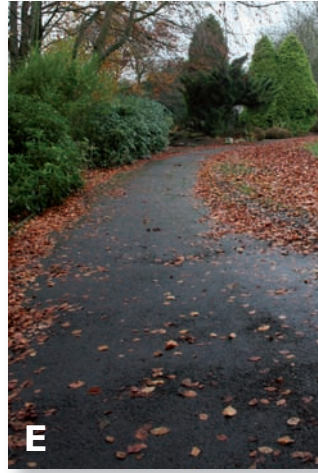
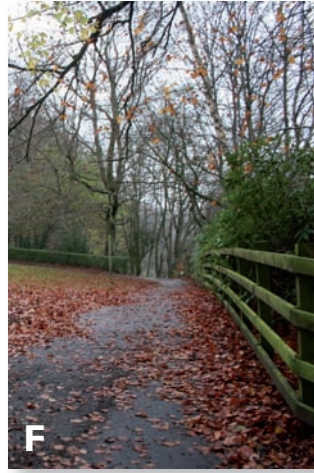
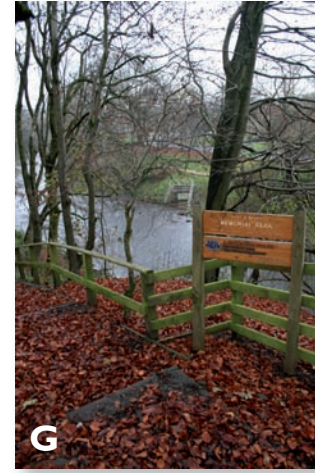
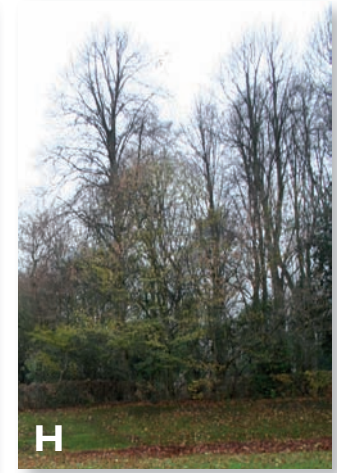
Ref	Characteristic or Feature	Good or Poor	Conservation Value	Potential Value
<b>D</b>	Mature hedge to northern, western and eastern boundaries	Good	<b>High</b> – good quality, mature hedge of healthy vigour	<b>High</b> - retain as boundary to performance space and include as major feature within Management Plan
<b>E</b>	Bituminous macadam footpaths 1.75m wide	Poor	<b>Medium</b> – the paths provide attractive and well-used circuitous routes although in poor condition and unlikely to meet modern access requirements	<b>High</b> – resurfacing work needs to be undertaken with possible consideration of use of differing materials to establish route hierarchies and staging posts for views, street furniture and disambulant users
<b>F</b>	Timber fence to south-eastern boundary	Good	<b>High</b> – of fairly recent construction and good integrity the fencing is unobtrusive and is a discrete element in the landscape	<b>Medium</b> – practical and efficient design response to safety issues that should be retained with thought possibly given to a new access from the Middle Slopes area down to the former Bandstand located on the Woodland Walk through the ruined Terraces

<b>G</b>	Signed entrance to Woodland Walk	Good	<b>High</b> – retain and include within Management Plan	<b>High</b> – retain, maintain and consider possible addition of mapping if the Walk can be expanded to link to the Riverside Walk to be constructed
<b>H</b>	Mature Tree Stock	Good	<b>High</b> – specimens appear to have survived from the Park's creation with additions considered to have been planted over the life span of the Park	<b>High</b> –retain and selectively thin out specimens (according to the AMP) to maintain health of stock as a verdant backdrop to the Performance space retaining the current sense of enclosure
